## FOUR POINT INSURANCE REPORT

Address Inspected: 123 Road West, town, FL 54321

Date Inspected: 1/9/2019

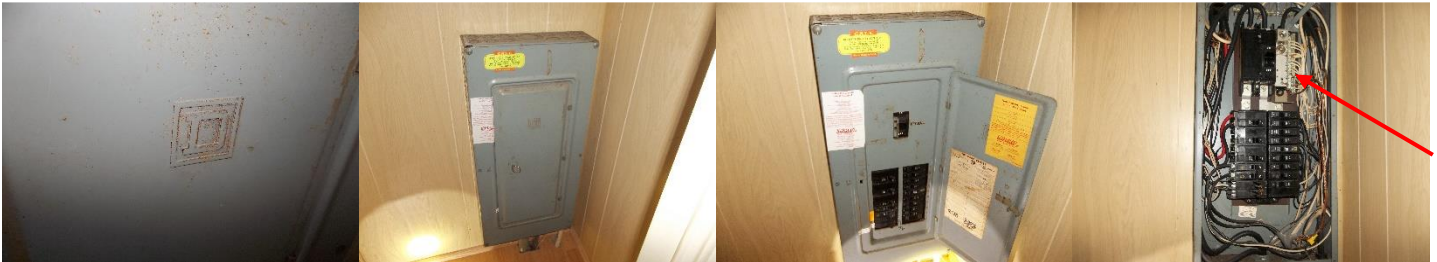
**Electrical System:**

Panel age: 50 YRS  
 Year last updated: 2011  
 Brand/Model: SQUARE D

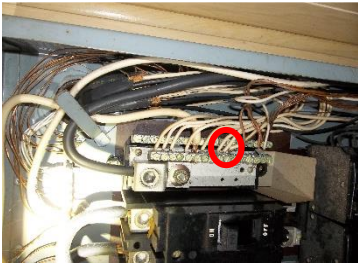
Electric Panel Has Improper Double Taps ON NEUTRAL BAR = Needs Repair

**Double taps on Neutral Bar**

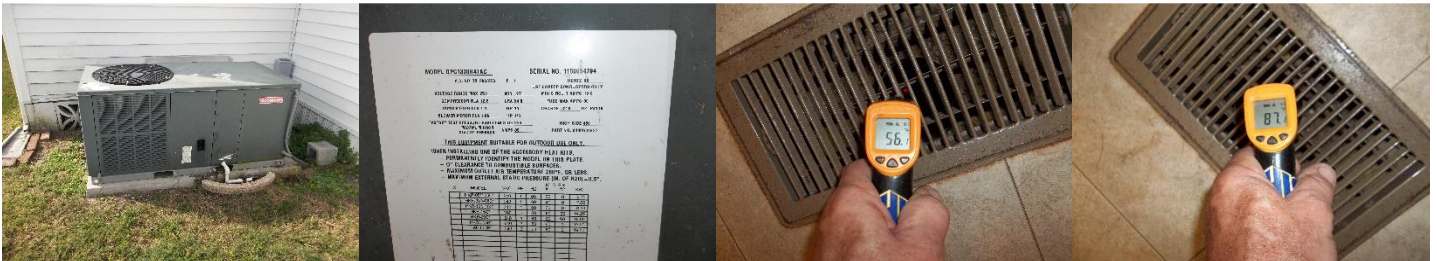
**Heating System:**

Age of system: 8 YRS

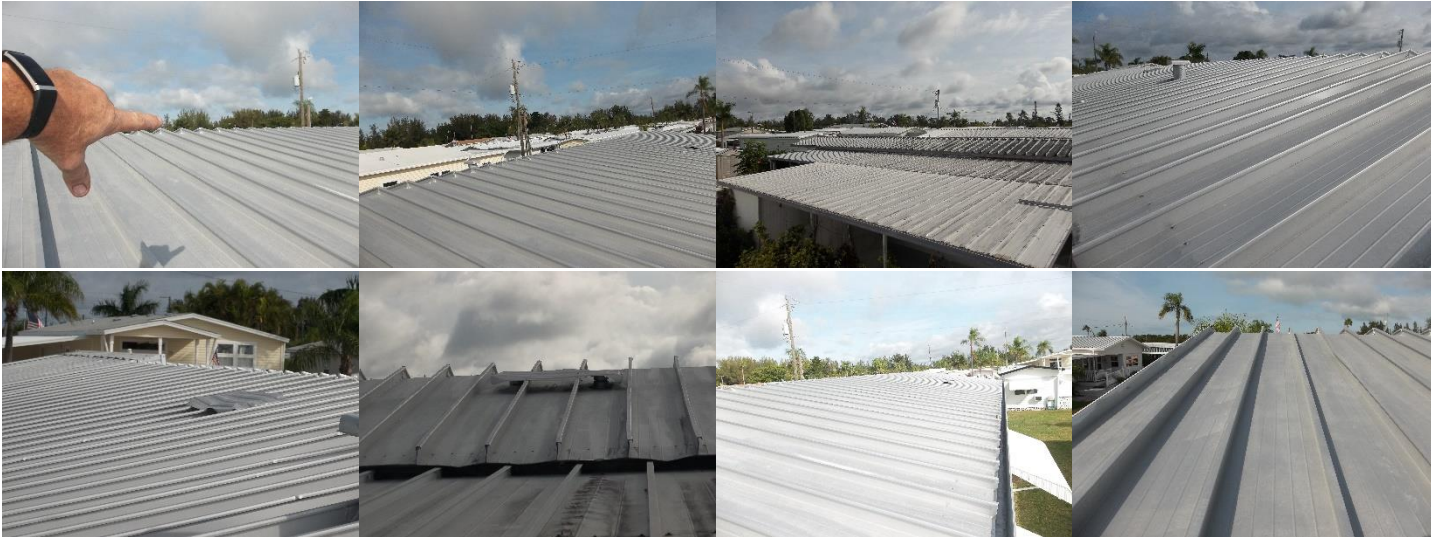
**Roof systems**

Covering material: METAL
Roof age (years): 50
Remaining useful life (years): 10 +
Date of last roofing permit: ORIGINAL
Date of last update: 1969
