# Uniform Mitigation Verification Inspection Form

Inspection Date: 11/9/2018		
<b>Owner Information</b>		
Owner Name: JOE CUSTOMER		Contact Person: JOE
Address: 123 Street		Home Phone:
City: CITY	Zip: 12345	Work Phone:
County: Manatee	Florida	Cell Phone:
Insurance Company:		Policy #:
Year of Home: 2004	# of Stories: 1	Email:

Inspector Initials KM Property Address 123 STREET, CITY, FL 12345

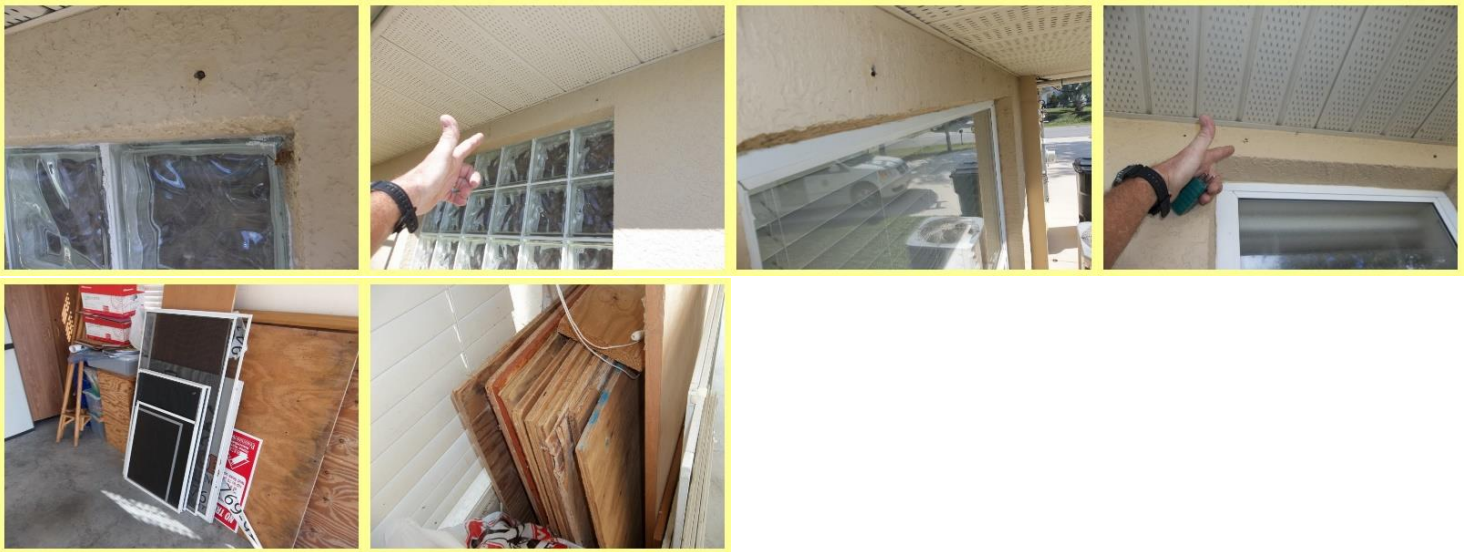
**Glazed Surface Protection:**

- B.3 One or More Non-Glazed openings is classified as level B, C, N, or X in the table above
- C. Exterior Opening Protection- Wood Structural Panels meeting FBC 2007** All Glazed openings are covered with plywood/OSB meeting the requirements of Table 1609.1.2 of the FBC 2007 (Level C in the table above.)

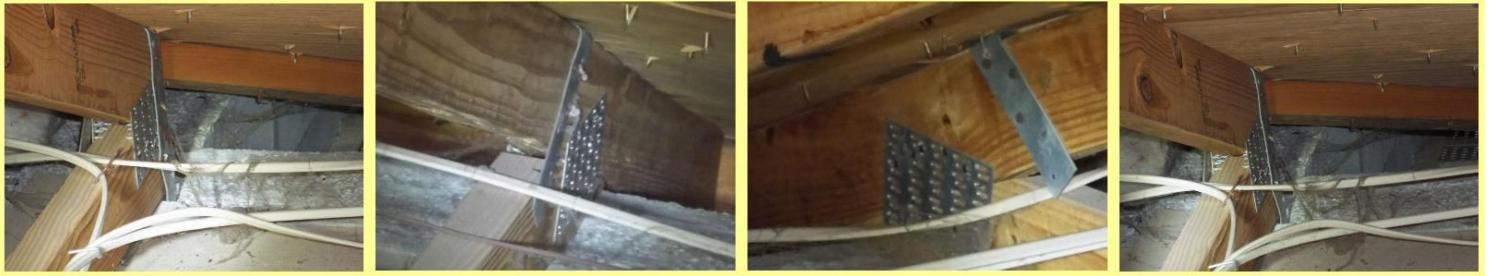
**Roof to Wall Attachments:**

4. **Roof to Wall Attachment:** What is the **WEAKEST** roof to wall connection? (Do not include attachment of hip/valley jacks within 5 feet of the inside or outside corner of the roof in determination of WEAKEST type)
